STUDY OF FAILURE AND RELIABILITY IN MICROELECTRONIC DEVICES

3rd QUARTERLY REPORT

May 1966

Librascope Group GENERAL PRECISION, INC.

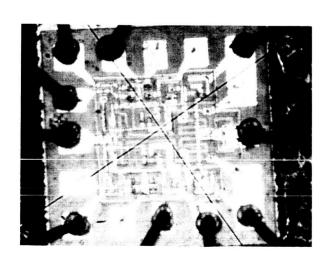
FIGURE 2

It is well known that the growth of purple plague is temperature dependent. This is verified by examination of the pictures in Figure 2 which shows the progressive growth of purple plague as a consequence of the three types of tests used.

a. (#16 after) 6,000 Hr. Life

b. (#54) After Cycling

c. (#85) After 350°C

Progress Growth of Purple Plague. Mag. 40X

During the temperature stress tests the thin film aluminum leads interact with the underlying insulator. This is evidenced by a loss in the reflective properties of the aluminum and the growth of a speckled appearance in the lead pad areas. Close examination of the lead pad areas of Figure 2a and the corresponding areas of Figure 3 illustrate this change.
- 3. Imperfections in Dense Lead Connection Areas,
 Failures tend to occur in regions of high density of thin
 film lead connections. The wide range of densities in
 lead connections is shown in Figure 4. There were no
 failures in the devices represented by Figure 4a through
 the 340°C stress test while there is a high incidence of
 failures in the device represented by Figure 4b even after
 only 200°C stress testing.

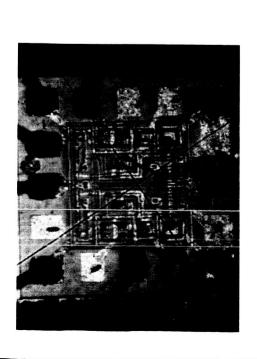
FIGURE 3

Erratic Growth of Purple Plague. Mag 40X All devices were subjected to temperature stress test through 350°C. Note also the speckled appearance of the thin film aluminium contact areas.

Figure 3. All circuits were subjected to the same test conditions, yet there is considerable variation in the growth of the plague from the lead pads into the circuit.
- 2. Progressive Aluminum Electrode-Insulator Interaction.
